# Manhole Inspection Summary

Manhole # S13S\_\_015MH

Insp Date: **1/6/09 1:53 PM**

**Location** Address: **3132 Wilkins Ave.**

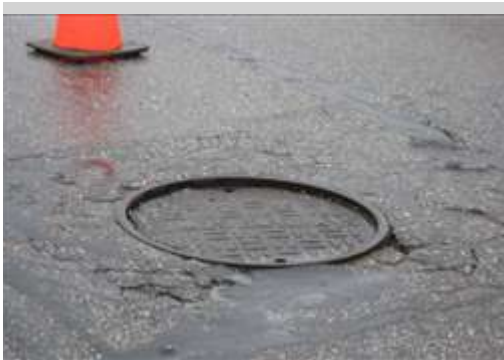
sunken lid

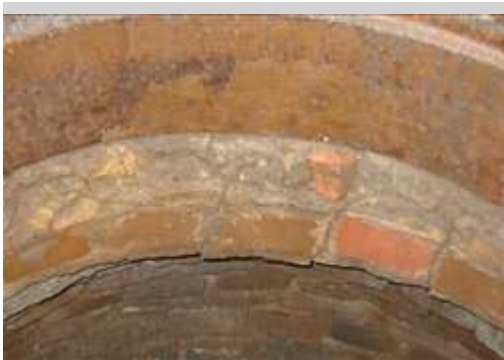
Defect 6

Condition: ☐ Sound ☒ **Cracked** ☐ Root Intrusion ☐ Loose Brick ☐ Deteriorated

Infiltration: ☐ None ☐ Joint ☒ **Cracks** ☐ Mortar ☐ Roots ☒ **Wall**

cracked chimney with infiltration

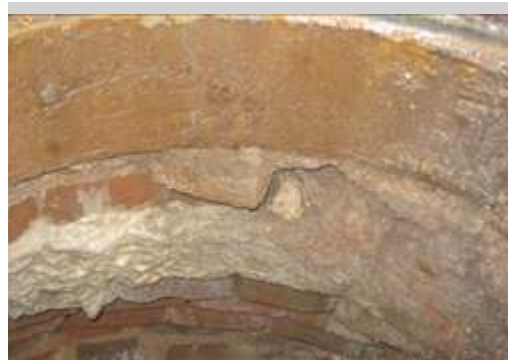
Defect 5

**Frame** Offset: **2.5** (in.) Condition: ☐ Sound ☐ Cracked ☒ **Leaks**

chimney and frame infiltration

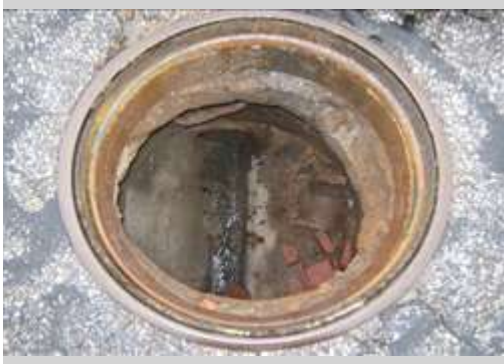
Defect 4

frame offset

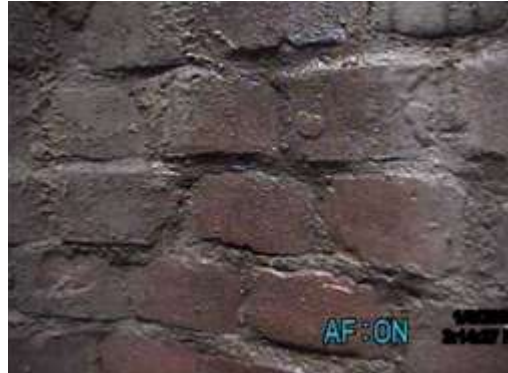
Defect 3

Infiltration: ☐ None ☐ Joint ☐ Cracks ☐ Mortar ☐ Roots ☒ **Wall**

corbel infiltration

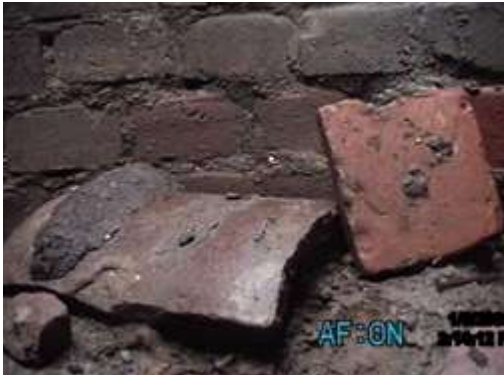
Defect 2

Condition: ☐ Sound ☐ Cracked ☐ Root Intrusion ☐ Deteriorated ☐ Leaks ☒ **Debris**

debris on the bench

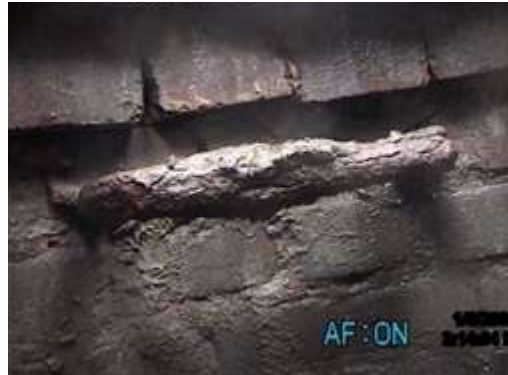
Defect 1

**Steps** Count: **1** Missing: **0** ☒ **Corroded**

corroded rung

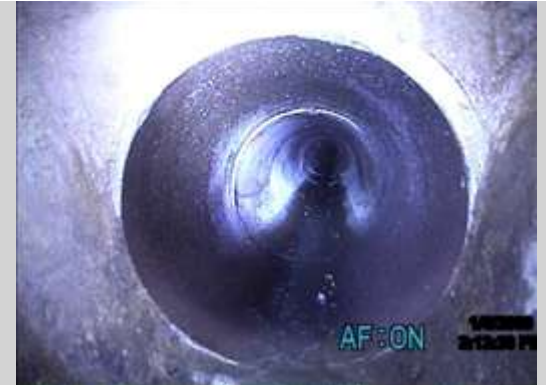
12 O'Clock Outflow

8 in. Circular Gravity Sewer  
Pipe Out @ 12 O'Clock

Pipe Height: **8.4** (in.) Rod and Bar (Angled)

Pipe Material: **Clay** ☐ Pipe Lined

Invert Depth: **4.60** (ft.) Flow Characteristics: **None**

Infiltration: **None** Pipe Seal Cond: **Sound**

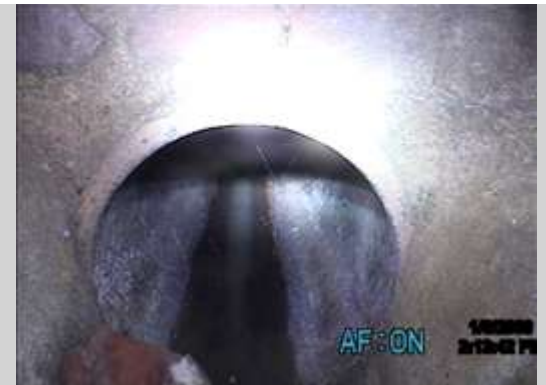
6 O'Clock Inflow

8 in. Circular Gravity Sewer  
Pipe In @ 6 O'Clock

Pipe Height: **8.4** (in.) Rod and Bar (Angled)

Pipe Material: **Clay** ☐ Pipe Lined

Invert Depth: **4.46** (ft.) Flow Characteristics: **None**

Infiltration: **None** Pipe Seal Cond: **Sound**
